Progressive Industries Lifetime Warranty Policy

Damage NOT COVERED Under Our Lifetime Warranty Policy

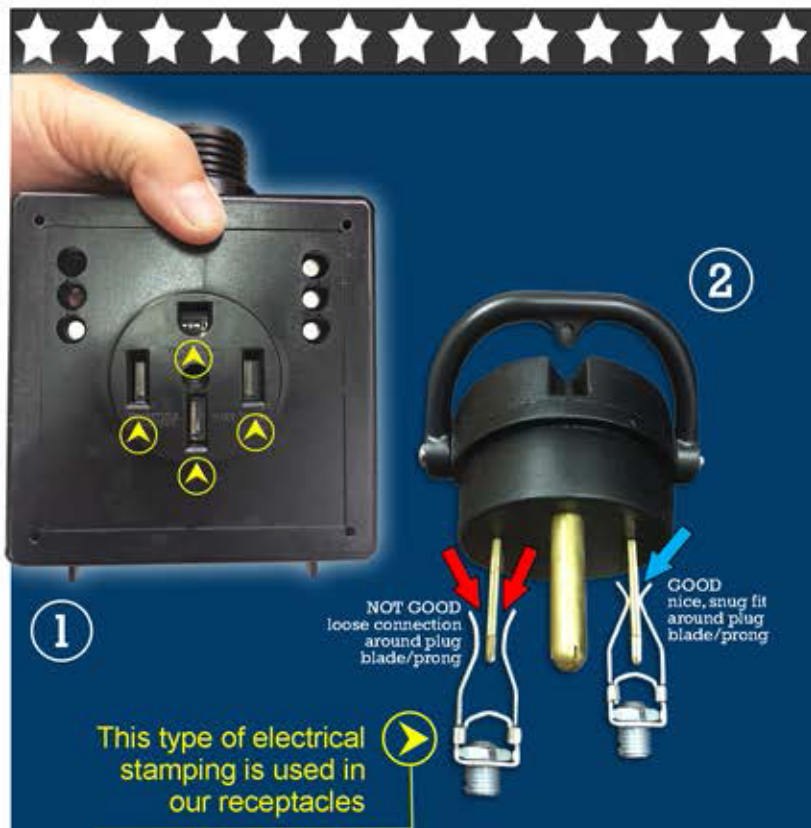
A Good Fit... Another problem we often see is a loose, sloppy fit. It is imperative the plug maintain a snug fit when plugged in. You may be tempted to wiggle the plug loose when disconnecting but over time this will compromise the connection making your unit susceptible to heat damage.

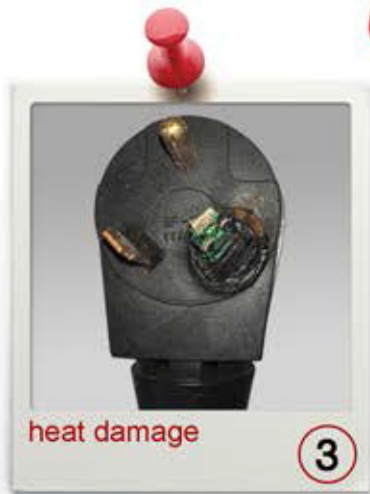
3

heat damage

A poor connection is typically due to old, dirty or poorly maintained plugs, adapters and/or prongs/blades. Before plugging in ensure your plug is clean and there is no pitting and/or discoloration on the pin/prong or blades. This will help safeguard the connection.

1. Pigtail showing excessive heat/melting damage (see image 8)
2. Front receptacle showing excessive heat/melting damage (see image 6)
3. Plug/prong, blades showing pitting and/or excessive heat/melting damage (see images 3, 4 & 5)
4. Damage caused by external plug or cord (see image 7)

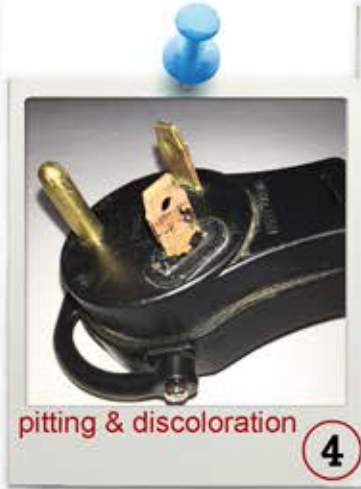
4

pitting & discoloration

You can always give the prong/blades a gentle clean with an emory cloth.

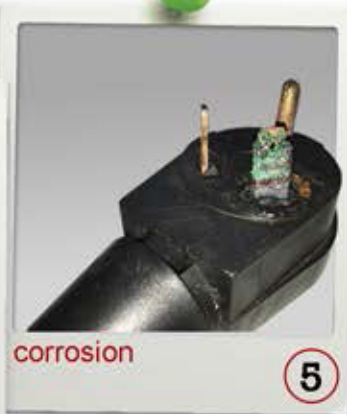
5

corrosion

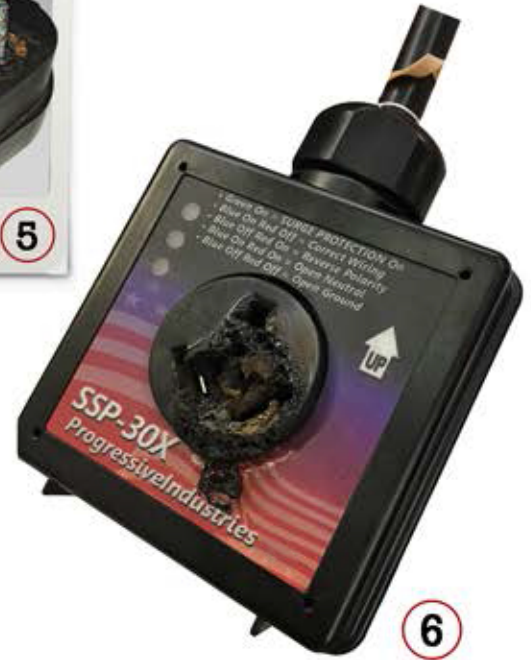
6

A poor connection forces the voltage to arch creating extreme heat which results in external melting.

Inspecting your electrical connections on a daily basis could help prevent damage to your unit.

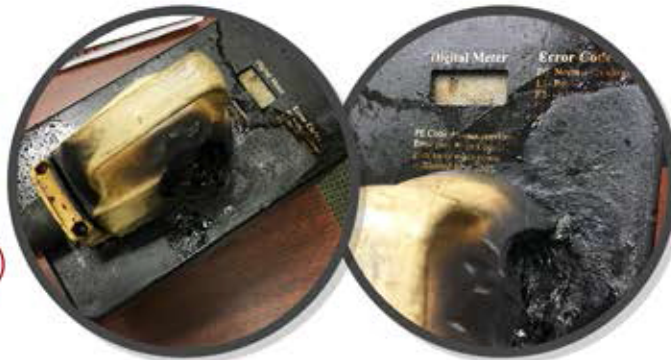
7

Excessive heat damage to plug

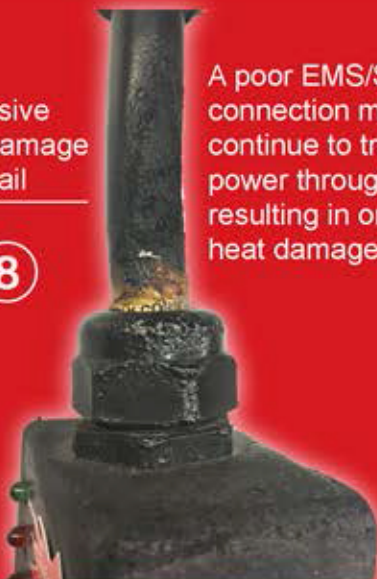
8

Excessive heat damage to pigtail

A poor EMS/SSP connection may continue to transfer power through, resulting in ongoing heat damage.
